Success Story

CONVEYOR RETROFIT IMPROVES MATERIAL TRANSFERS, REDUCES SPILLAGE

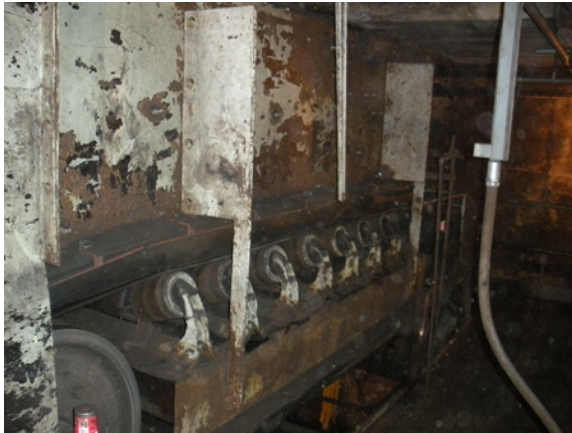
NIPSCO before: MCGS took a proactive approach to upgrading conveyor feed systems, conducting a plant-wide assessment and implementing a program designed to reduce fugitive dust and spillage.

Rather than scheduling a full plant outage, the installation was completed during a single-shift outage. A 3-man crew from Martin Engineering first rebuilt the load zone on the belt feeder below the railcar dump, where the skirting and liners were worn out and the support structure below the belt had deteriorated over the years. Next, the technicians pre-fabricated additional support structure to be installed below the idlers, designed so it could be moved into place through very confined spaces. When all sections were replaced or repaired, they went to work on the wear liner and skirtboard.

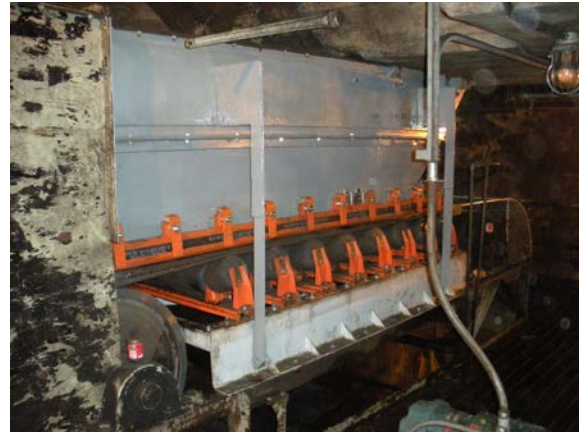
NIPSCO after: The EVO™ External Wear Liner is designed to remove the material burden from the dust containment system, diverting the bulk of the load away from the sealing components and extending their service life.

Martin Engineering was selected as a primary resource for the upgrade, including retrofit wear liners on the four feeders below the rail car dump, as well as on the two feeders from the reclaim line. The wear liners are designed to remove the material burden from the dust containment system, so the bulk of the load is diverted away from the sealing components, keeping the coal away from the elastomer seal and extending system life. Available in 3/8" or 1/2" thick abrasion-resistant plate, the liners mount to the outside of the existing transfer point skirtboard.

Martin Engineering's EVO® Modern Conveyor Architecture offers a new concept in wear lining - putting it outside the skirtboard. This technique offers several benefits. For one, it allows precision alignment of steel panels to avoid points that entrap material and damage the belt. The approach also facilitates easier inspection of the liner -- and easier replacement when required -- both without confined space entry. Because the wear liner is directly against the elastomer sealing system (without skirtboard steel between the liner and seal), there is no room for material buildup. This improves the performance of the liner and skirtboard sealing system, without adding to the cost of conveyor construction.

Attached on unique mounting blocks, the wear liner is readily adjustable through a specially-designed bolt-on alignment system that delivers precise control to reduce spillage. The components are designed to fit conveyors with trough angles from 0° to 35°. Special cutaways simplify installation, without modifying existing skirtboard supports. Worn internal wear liners can be left in place, as long as there is no risk of trapping material or damaging the belt.

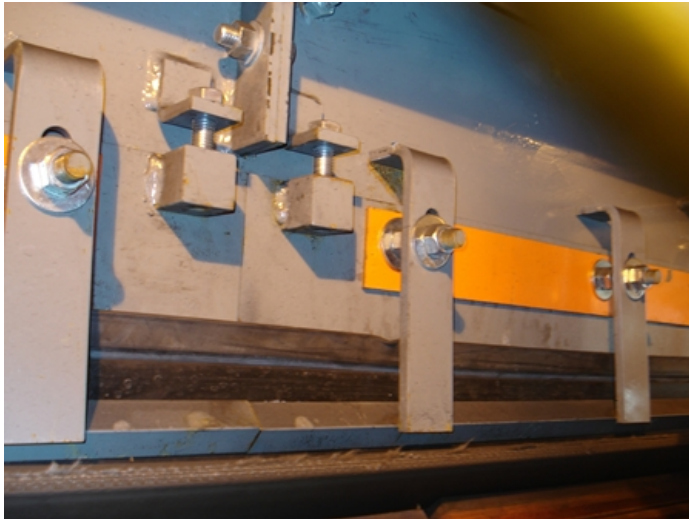
The wear liner is installed outside the transfer chutes, eliminating the need for confined space entry and avoiding a full tear-out of the existing chutes.

“All work was performed outside the chutes, so we didn't need a lengthy downtime to install the new components,” commented Martin Engineering Installation Technician Tony King. “Because it's positioned on the outside, the EVO® External Wear Liner saved labor and eliminated the need for confined space entry, without requiring a full tear-out of the existing chutes.”
