PROBLEM SOLVED™ PAPER

SOLUTION: MartinPLUS® Process Improvement & QC2™ Cleaner

INDUSTRY: Coal-Fired Power

LOCATION: Brayton Point Station, Somerset, MA

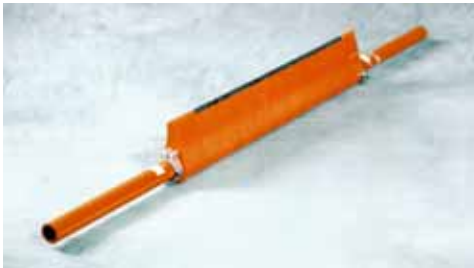
Martin® QC2™ Cleaner

A standardized belt cleaning system has been installed on fourteen conveyors. To provide very consistent tensioning and minimize the amount of maintenance that the cleaners require, all belt cleaners have been installed with air tensioners, connected to the plant air system. A specially designed air bag tensioner for the Martin® QC2™ Cleaner was developed for this plant.
