PROBLEM SOLVED™ D5D9F

SOLUTION: Martin® Transfer Point Products and MartinPLUS® Installation Services

INDUSTRY: Coal-Fired Power

LOCATION: City of Ames Power Plant Ames, Iowa

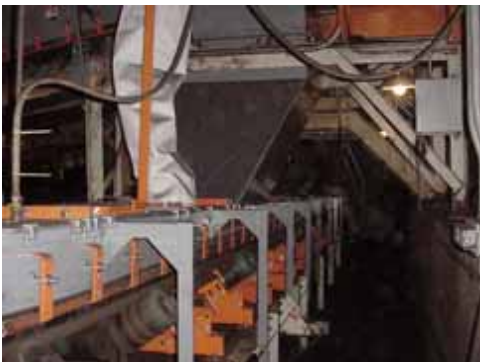
Included in the coal-conveying system reconstruction was the installation of Martin® ApronSeal™ Skirting and Martin® Dust Bag.

To refurbish its coal handling system, the plant agreed to a conveyor rebuild by Martin Engineering. Project scope included two belt feeders and two conveyors as well as their respective loading and discharge points. Work included the construction of new chutes and installation of a variety of Martin Engineering transfer point components, including Martin® Impact Cradles, Martin® Support Cradles, Martin® ApronSeal™ Skirting, Martin Wear Liner and Martin® Tracker.

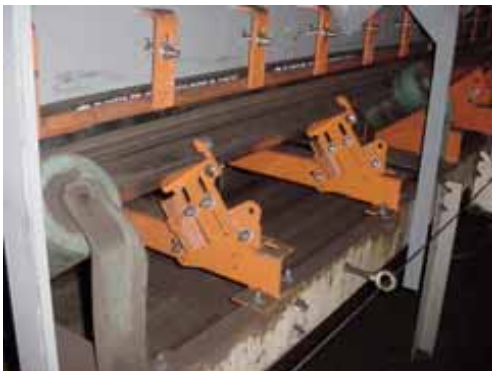
Martin® Support Cradles were installed to stabilize the belt path and reduce spillage.
